North Sydney Boys
High School –
Proposed Carpark &
Sports Courts

Geotechnical
Investigation

Report No: 01-GG13A

Date: July 2001

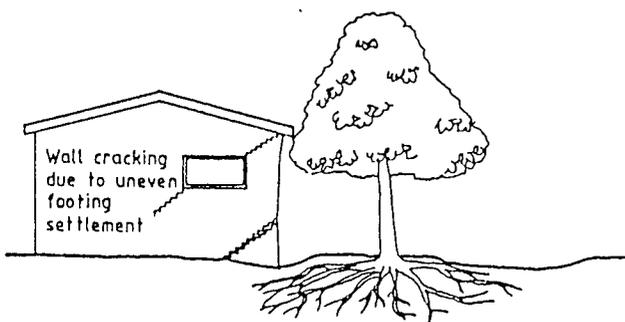
Trees and large shrubs require substantial amounts of water, and if the soil near the tree dries out, the roots will extend in search of soil moisture. Tree watering is important in late summer and in drought. The use of slow drip watering systems may be appropriate. It has also been found useful to drill holes near trees and fill them with gravel to allow water better access to the tree roots. Otherwise, clays will shrink as they dry, and a house may settle as shown below.

TREES CAUSE SHRINKAGE AND DAMAGE

Many factors determine the extent of clay drying by trees, and the more important include the soil type, the size and number of trees, and their species. Trees obtain moisture from roots that spread sideways and the drying zone is influenced by the extent of these roots. For single trees, the drying zone is usually one-half to twice the tree height, but the zone may be larger for groups or rows of trees. Although it is known that the species can influence the extent and severity of the drying zone, little definite information is available. Some Australian trees are particularly efficient in extracting water from very dry soils and can be more dangerous than non-Australian species that use large amounts of water in normal conditions. The effect of tree drying on the amount of movement is also related to the reactivity of the clay. To minimise the risk of damage, trees (especially groups of trees) should not be planted near the house on a reactive clay site, and the following limits are recommended.

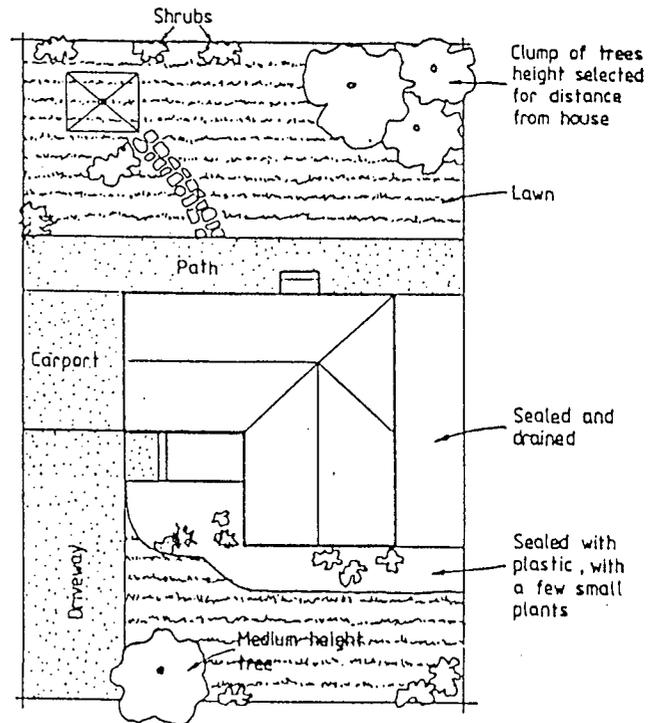
Large garden beds are best not located near the house. This will avoid the possibility of introducing too much moisture to the foundation clay by over watering. The zone near the house should be planned for paths or covered with gravel and plastic sheeting. Small shrubs may be planted at reasonable spacings.

GARDENS FOR REACTIVE SITES

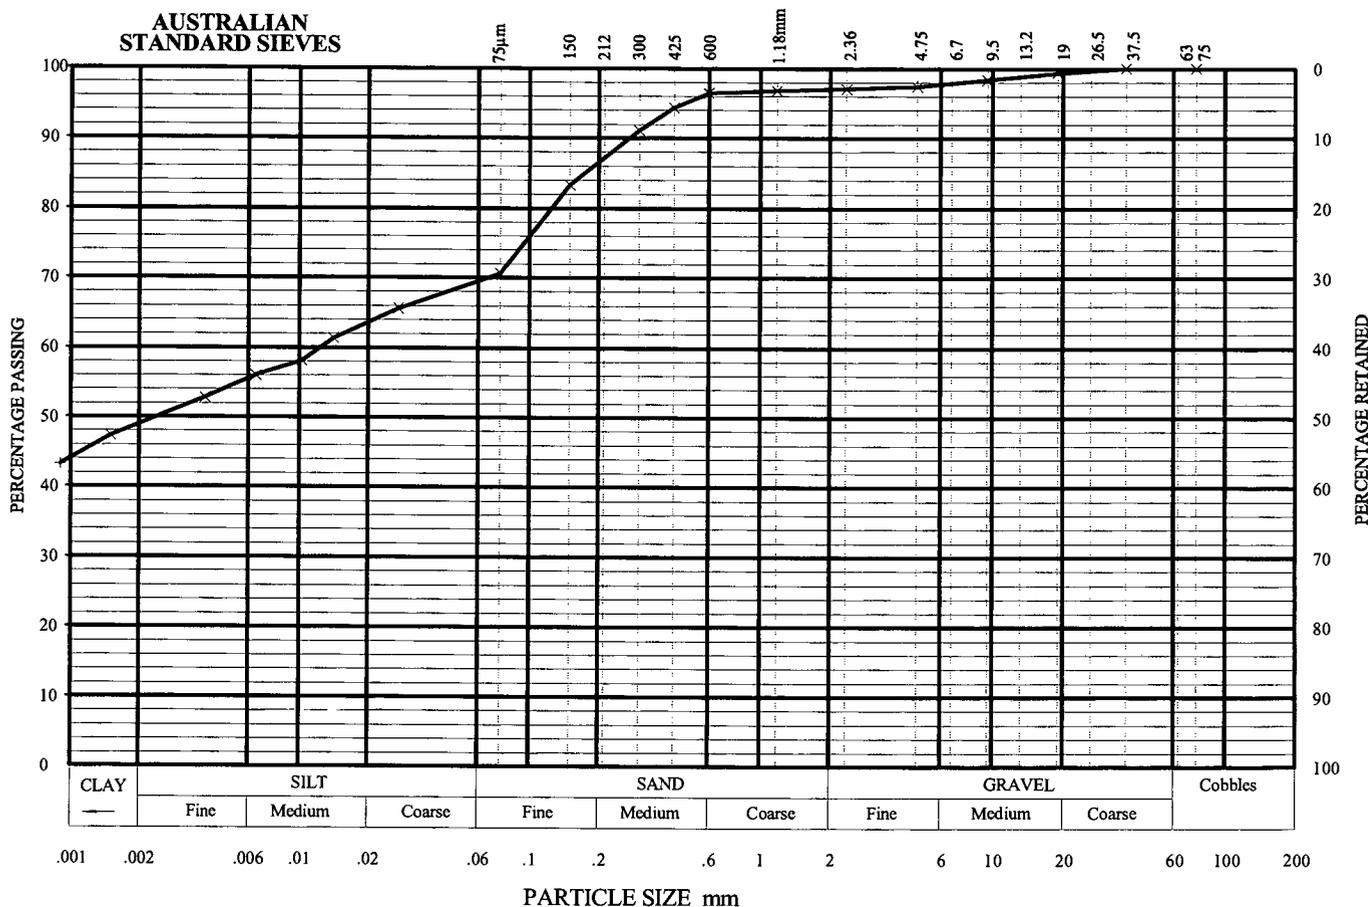
PARTICLE SIZE DISTRIBUTION R1119 (ISSUE 2, 1998)

PROJECT: North Sydney Boy's High School SAMPLE No: 4779

LOCATION: Carpark and Sports Courts HOLE No: B2 DEPTH (m): 0.6

Two bulk samples were taken from borehole B2 (0.6-0.9m, silty clay with sand) and B3 (0.8-1.3m, sandy silty clay) for CBR testing. These boreholes were located within the proposed carpark area. The sample taken from borehole B3 is fill. The samples were remoulded to a dry density ratio of 101% standard, and a soaked CBR value of 5% was obtained for both samples. Considering our experience with the similar materials, and the potential for ground variation, a CBR value of 4% is recommended for pavement design.

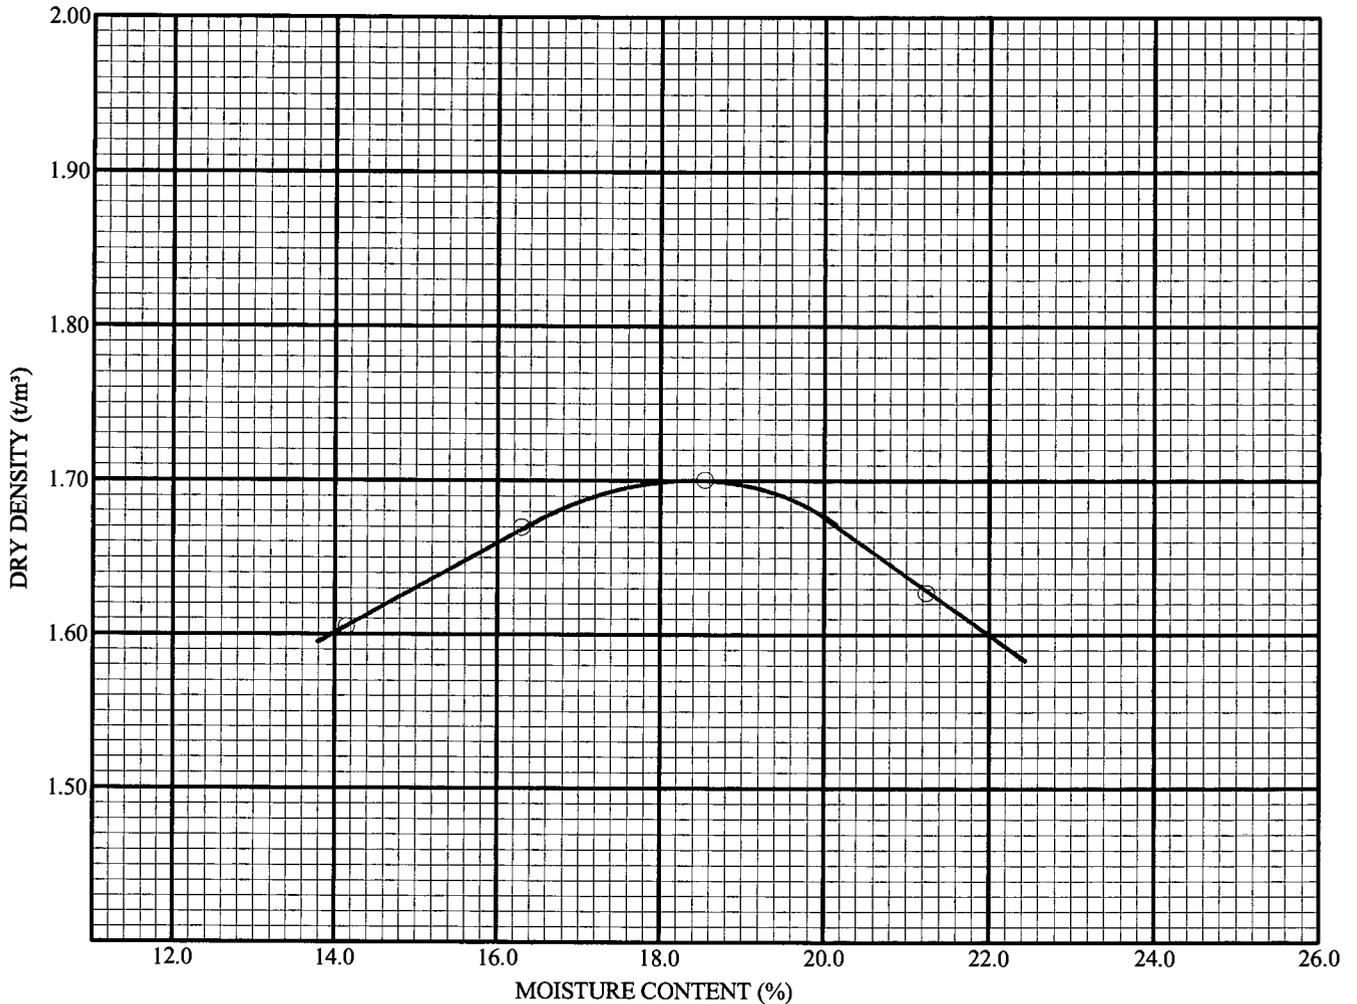
COMPACTION R1111 (ISSUE 2, 1998)

Standard Maximum Dry Density:	1.70 t/m ³
Standard Optimum Moisture Content:	18.5 %
Percentage of Material Retained on the 19 mm sieve	0.6 %
Notes on Test: Specimen tested as received from client	
Test Method: AS 1289.5.1.1	Mould: A (1 Litre) <input checked="" type="checkbox"/> B (2 Litre) <input type="checkbox"/>

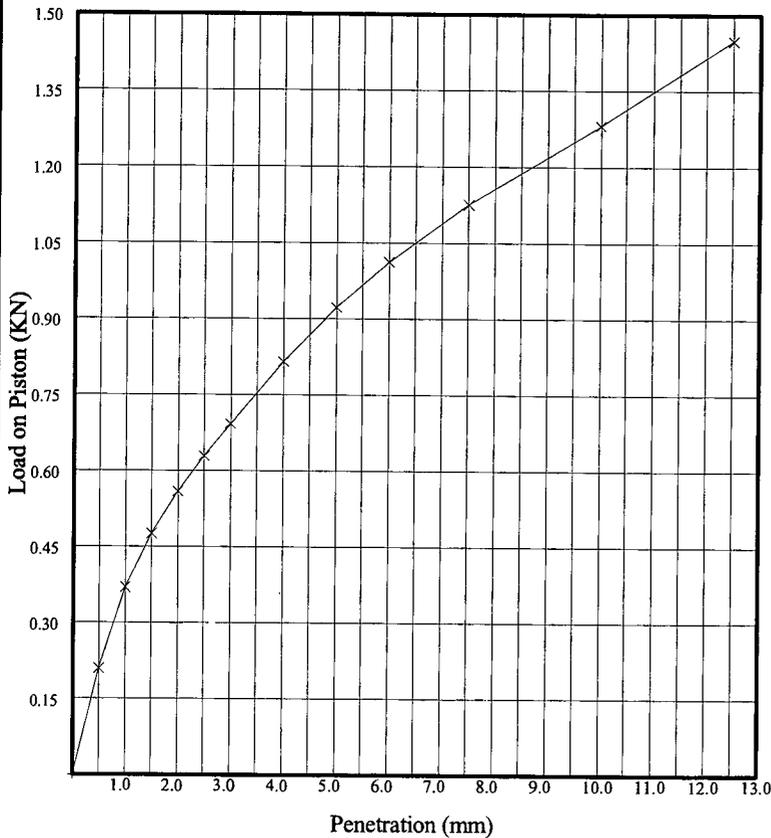
CBR at 2.5 mm % 5.0

CBR at 5.0 mm % 4.5

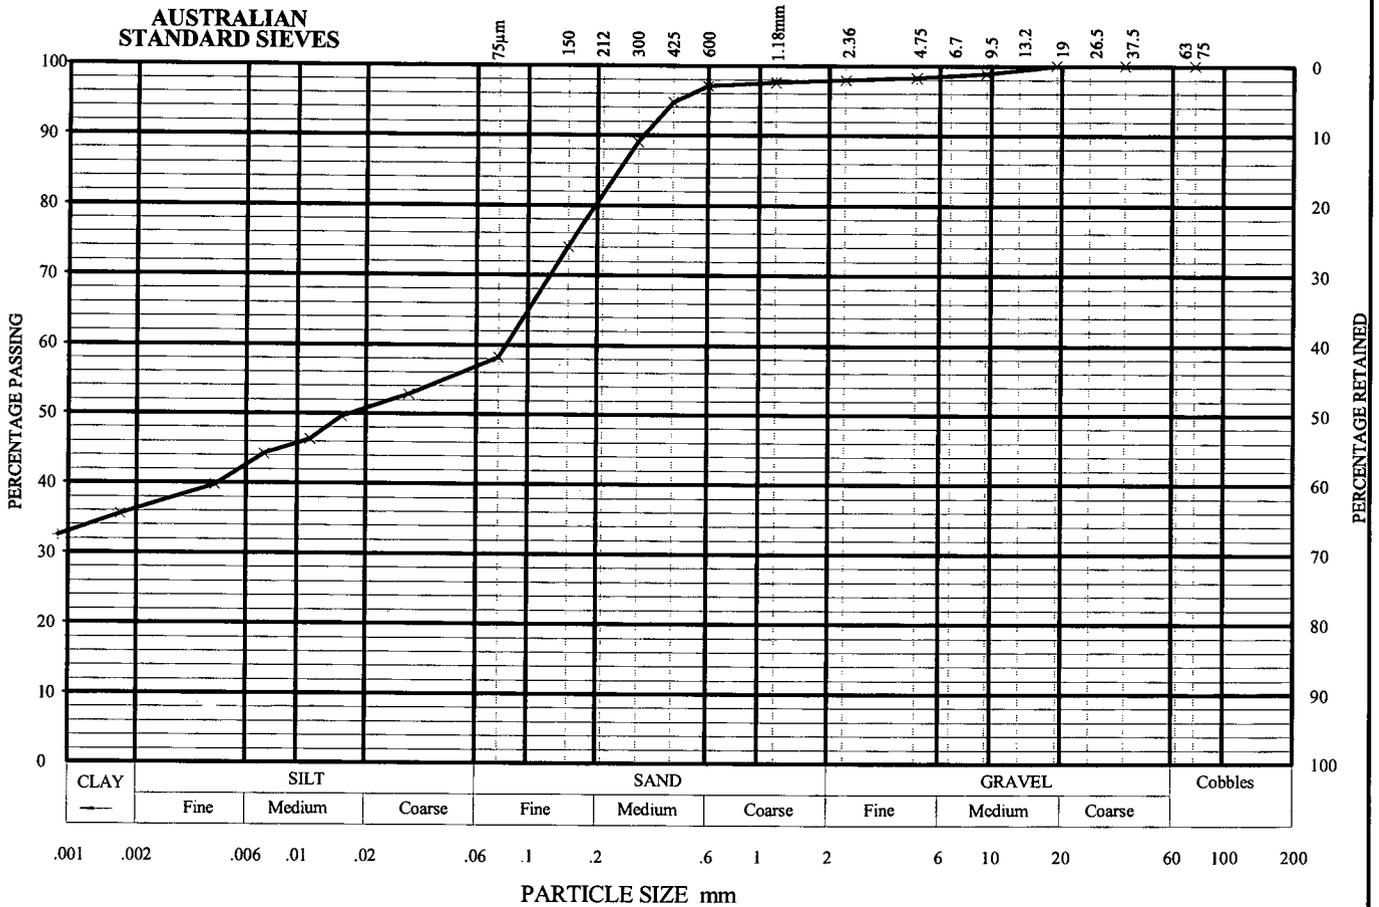
PARTICLE SIZE DISTRIBUTION R1119 (ISSUE 2, 1998)

PROJECT: North Sydney Boy's High School SAMPLE No: 4781

LOCATION: Carpark and Sports Courts HOLE No: B3 DEPTH (m): 0.8

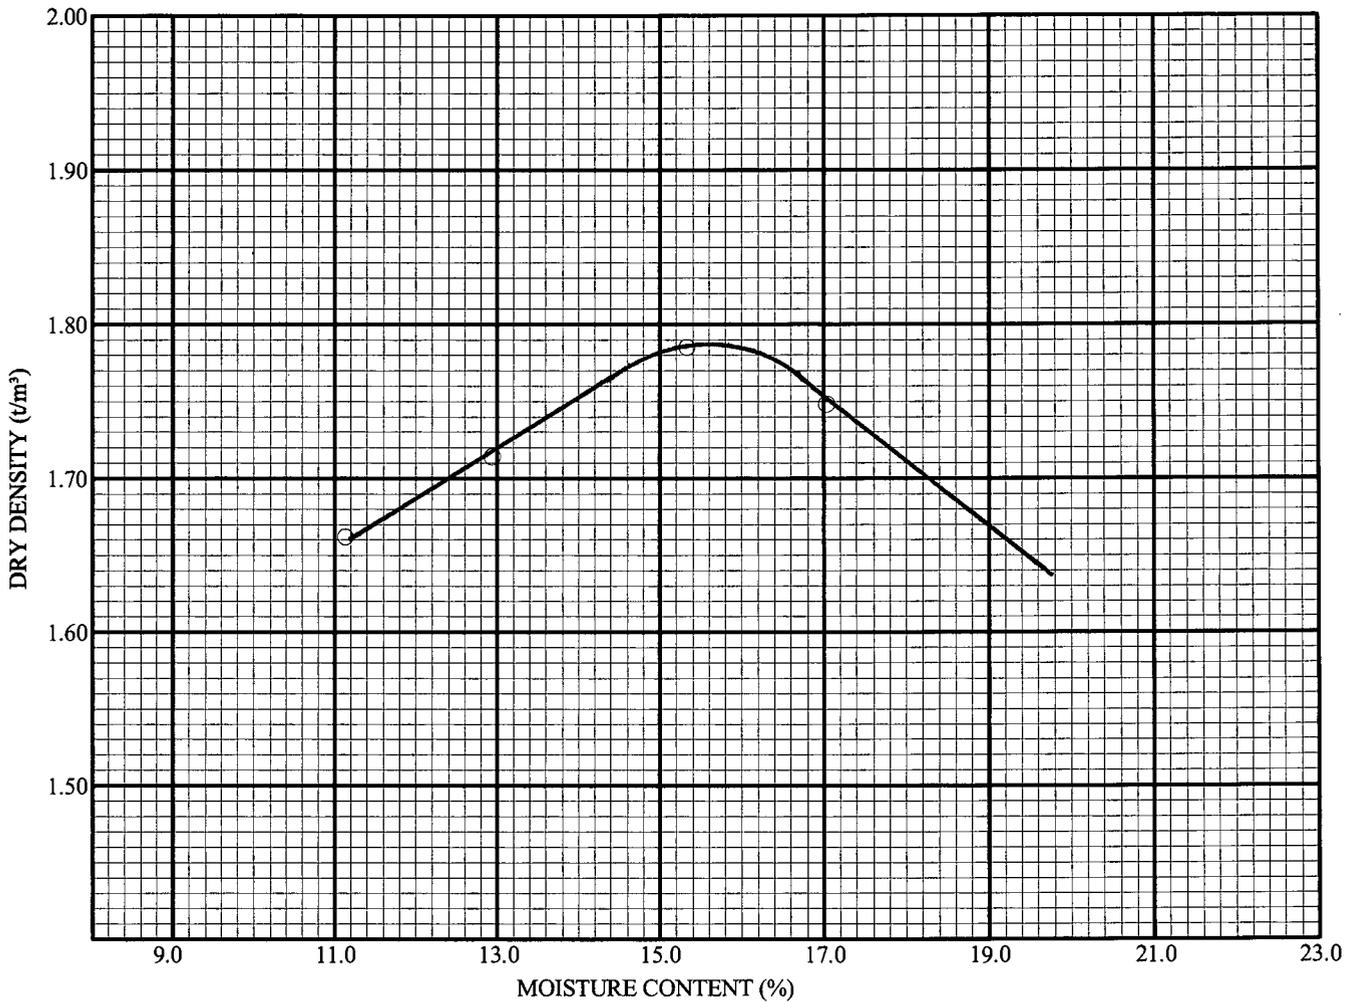
COMPACTION R1111 (ISSUE 2, 1998)

Standard Maximum Dry Density:	1.79 t/m ³
Standard Optimum Moisture Content:	15.5 %
Percentage of Material Retained on the 19 mm sieve	0 %
Notes on Test: Specimen tested as received from client	
Test Method: AS 1289.5.1.1	Mould: A (1 Litre) <input checked="" type="checkbox"/> B (2 Litre) <input type="checkbox"/>

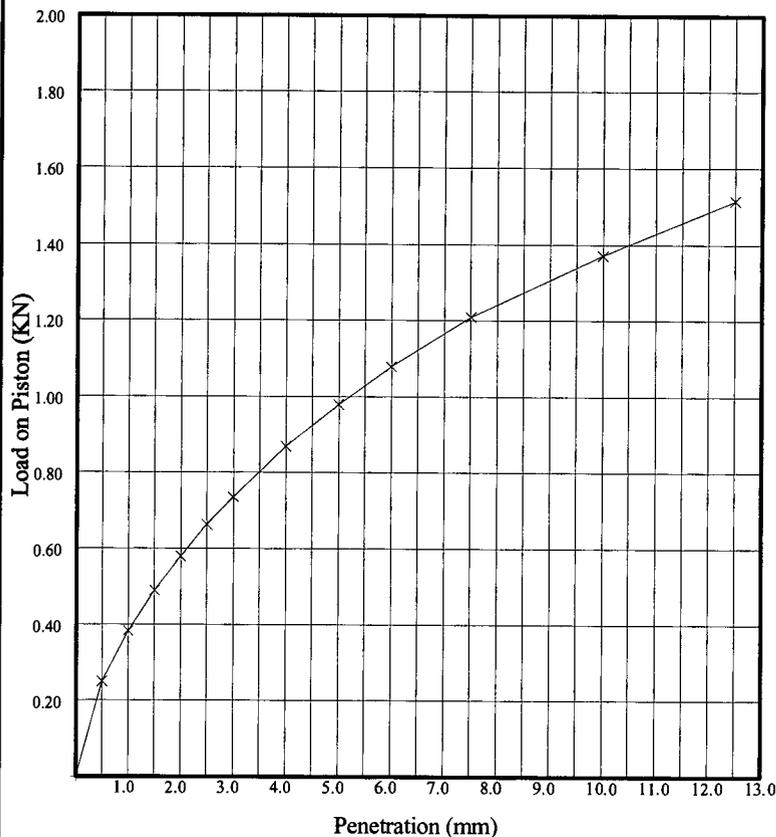
CBR at 2.5 mm	%	5.0
CBR at 5.0 mm	%	5.0
Surcharge Mass	kg	4.5
Compaction Type		
<input checked="" type="checkbox"/> Standard (AS1289.5.1.1)	<input type="checkbox"/> Modified (AS1289.5.2.1)	
Soil Description: Grey Brown Sandy Silty Clay		
Sample Condition:		
<input checked="" type="checkbox"/> Soaked (4 days)	<input type="checkbox"/> Unsoaked	
Material retained 19 mm : 0.0%		
Included	Y <input type="checkbox"/> N <input type="checkbox"/>	
Notes on Test: Specimen tested as received from client		
Test Method: AS1289.6.1.1

Density Parameters			Moisture Parameters		
Maximum Dry Density:	t/m ³	1.79	Optimum Moisture Content:	%	15.5
Dry Density Before Soak:	t/m ³	1.80	M.C. Before Soak:	%	15.7
Percentage of M.D.D:	%	101	Percentage of O.M.C:	%	101
Dry Density After Soak:	t/m ³	1.80	M.C. After Test-top 30 mm:	%	16.8
Percentage Swell	%	0.2	M.C. After Test-whole:	%	15.8

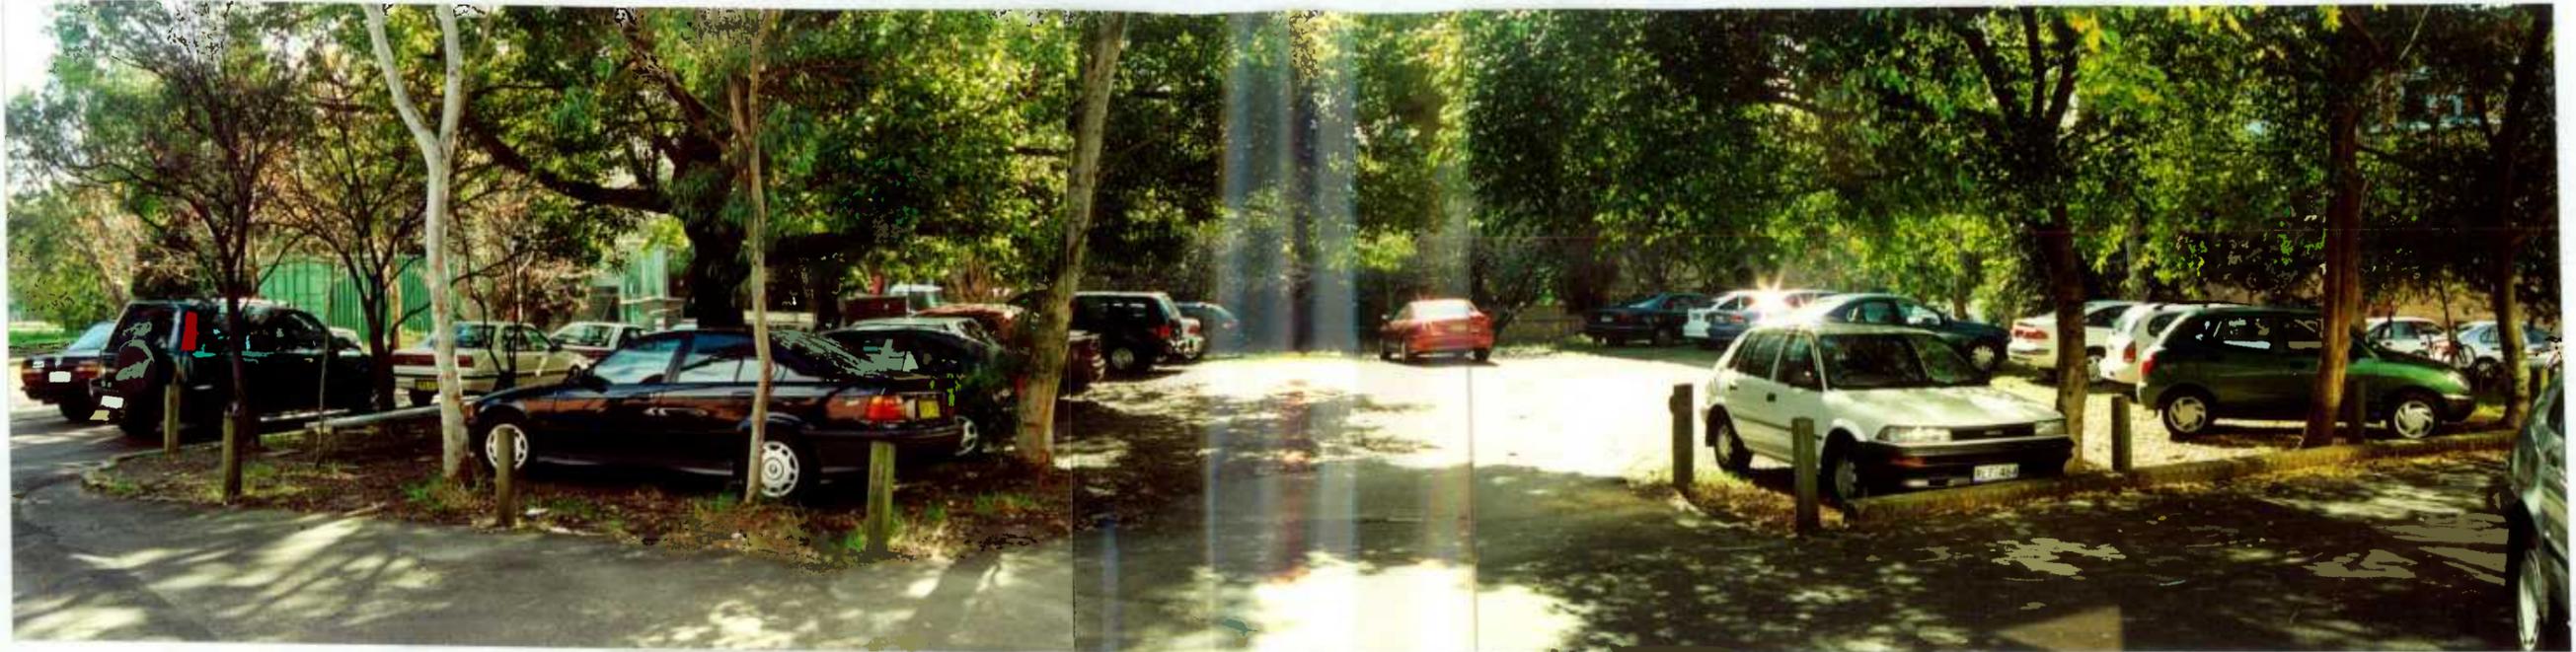
PHOTO 1: General view of the proposed carpark area.

Generally the site slopes very gently towards north, and is intercepted by low height brick walls near the northern and eastern site boundaries. The proposed carpark area (area A, see **Photograph 1**) is generally bare with some trees. The proposed sports courts area (area B, see **Photograph 2**) is generally grass covered with some trees. A patch of bare surface and a shipping container occur along the eastern boundary of area B.

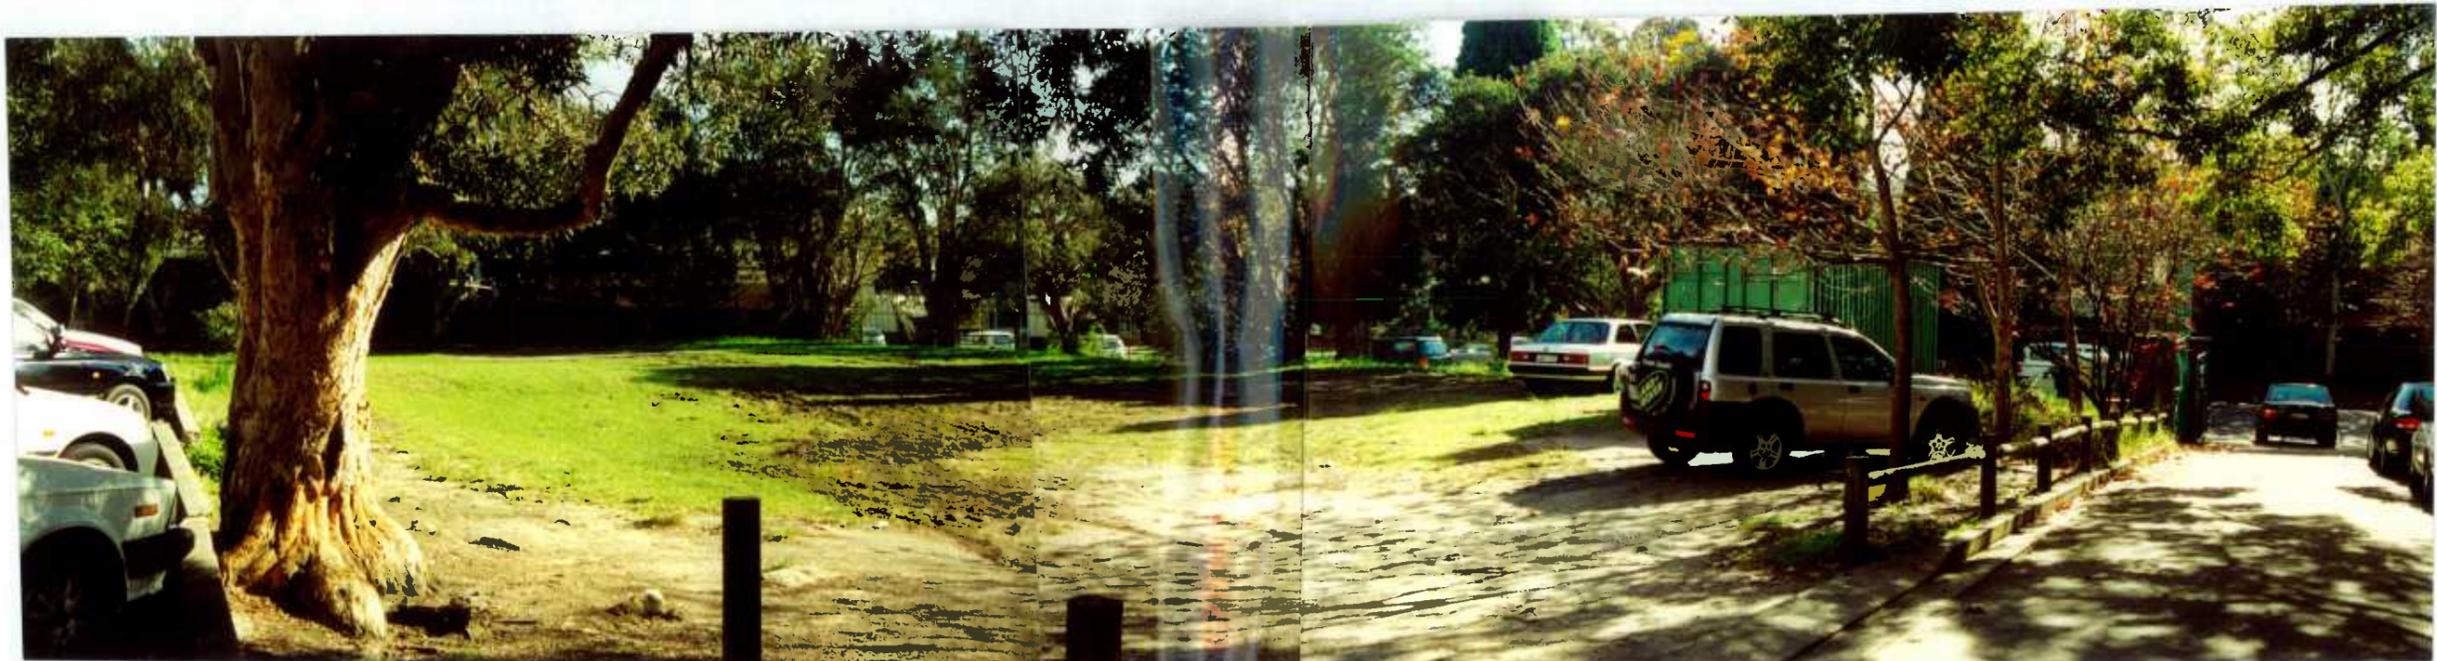
PHOTO 2: General view of the proposed sports courts area.
